## SERVICE BULLETIN

| <b>Reference number:</b> | <b>SB-01-1054</b> | <b>Issued: 30 January, 2018</b> |
| <b>Subject:</b> | <b>DB11 Rear Windscreen Leaks</b> | |
| <b>Model(s):</b> | <b>DB11 Coupe</b> | |

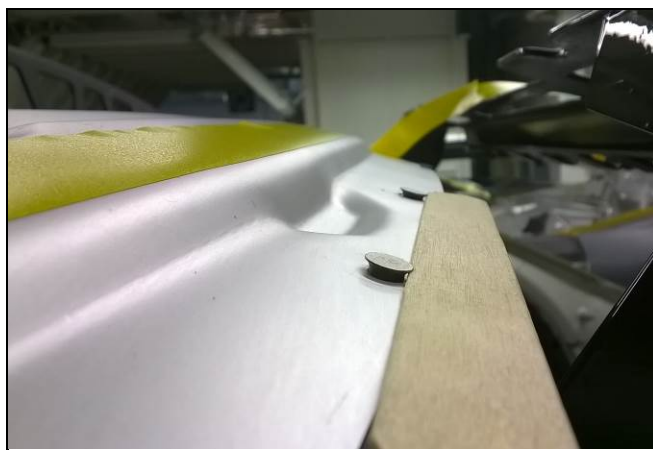
**Figure 1**

Aston Martin has found that some DB11 vehicles have had water leaks through the windscreen. The primary cause of the problem is that some of the rivets in the body structure were not installed flush. This can cause a failure in the sealant bond for the windscreen.

When the windscreen seal has this defect, water can leak on to the parcel shelf and/or on to adjacent areas of the vehicle interior. If there is an indication of a leak, do the workshop procedure that follows.
