## QUARANTINE NOTICE

| Reference number: | QN-03-0050 | Issued: 10 January 2017 |
| Subject: | Examine the coolant hose for the auxiliary radiator on DB11 | |
| Model(s): | DB11 | |

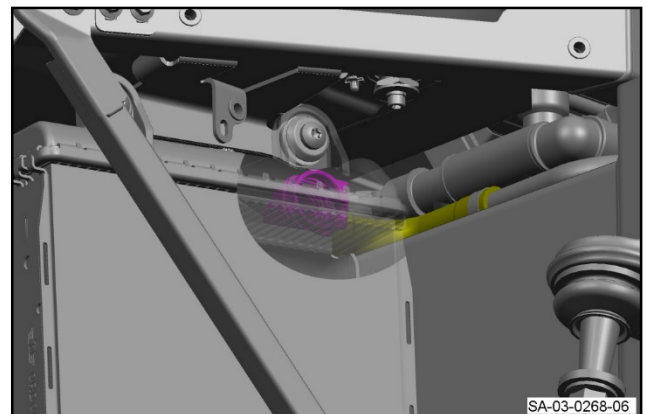
Figure 6

A spigot for a coolant hose may be out of tolerance on the left side auxiliary radiator on some early build DB11 vehicles. A check must be done to make sure the outlet hose for the Water-Air Charge Air Cooler (WACAC) is correctly connected to the auxiliary radiator.

7. Examine the WACAC hose connection into the left side auxiliary radiator (refer to Figure 6). It is possible that the attachment clip is not fully engaged to hold the hose correctly.
8. If necessary, push the clip down from the top until it engages in the installed position to attach the hose.
