## QUARANTINE NOTICE

| Reference number: | QN-06-0053 | Issued: 01 February 2017 |
| Subject: | ESP Module Software Update | |
| Model(s): | DB11 | |

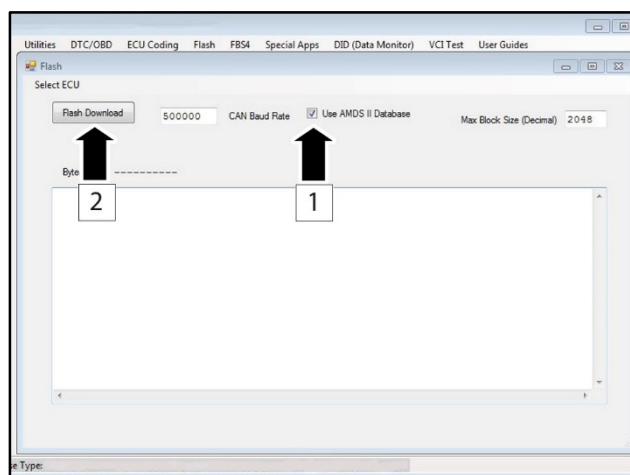
Figure 2

4. Select "Use AMDS II Database" (refer to Step 1, Figure 2).

5. Click on the "Flash Download" button to start the update procedure (refer to Step 2, Figure 2).
6. The update is an automatic procedure. Approximately six or seven minutes are necessary to do the procedure.
7. The update is complete when you can read "Post-programming sequence completed OK. VCI Disconnected. DRVU reset OK" in the display. Close the "Flash" window.
8. Do a check for DTCs stored by the ESP module. Erase all the DTCs that the module has stored.
