| SERVICE ACTION RECALL | | |
| <b>To:</b> All Dealers / MEAM<br><b>For the attention of:</b> The Dealer Principal<br><b>Please copy to:</b> The Service Manager<br>The Sales Manager<br>The Parts Manager<br>Warranty Administrator<br>Aston Martin Technician(s) | <b>Reference:</b><br>SAR 011<br><br><b>Issued:</b><br>November 2005 | <b>Page:</b> 1 of 5 |
| <b>Model:</b> DB9 | | |
| <b>Subject:</b> ZF Automatic Transmission -Parking Pawl Glide Plate | | |

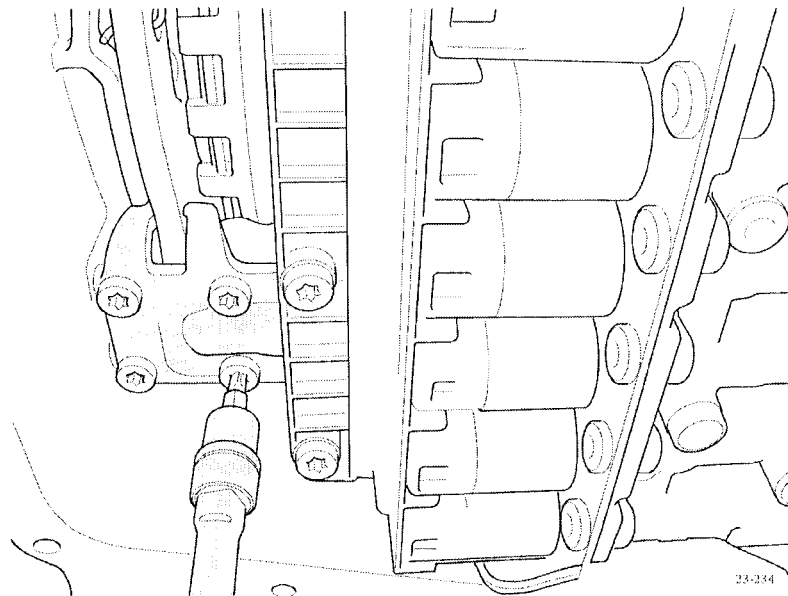
Figure 1

Following field investigations, it has been identified that a number of Aston Martin DB9 models have been assembled with an automatic transmission (parking pawl glide plate) that may not have been subjected to the required heat treatment process and therefore is not hardened correctly. Consequently, Park may not engage even if the park button in the vehicle is pressed to select Park and all driver indicators show the Park position has been achieved.

- Remove the rear sub-frame cross-member
- Remove the left-hand rear exhaust pipe
- Disconnect the oil cooler pipes from the gearbox at the thermostat and remove the pipework/thermostat assembly
- Drain the gearbox oil into a clean container for re-use, and refit the drain plug
- Remove the gearbox oil pan
- Locate and remove the Park Pawl Guide Plate by removing the four Torx screws and ease the old plate out of the gearbox, (see figure 1). Retain the displaced part for warranty return

- Fit the new Park Pawl Guide Plate and tighten the four Torx screws to 10Nm
- Check the park pawl is free to move
- Refit the gearbox oil pan, (confirm that the original gasket is clean and fully seated before refitting the gearbox oil pan) and cross torque all screws to 7-9Nm
