**SERVICE BULLETIN**

| <b>To:</b> | All Dealers | <b>Reference</b><br>SB-01-0361<br><br><b>Issued:</b><br>10 April 2013 |
| <b>Model:</b> | Vanquish 13MY | |
| <b>Subject:</b> | Upper A-Pillar Trim Repair for Vanquish 13MY | |

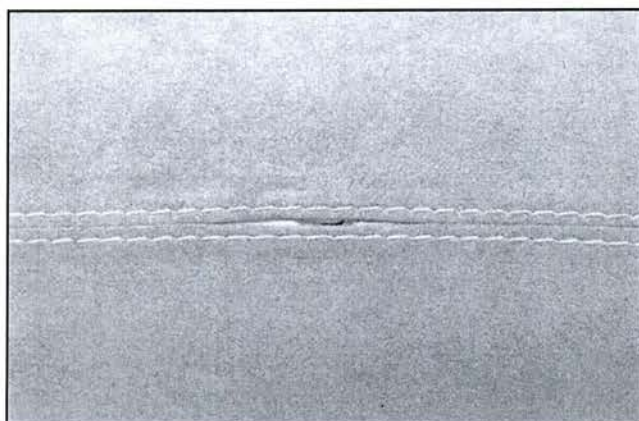
Figure 1

It is possible for the alcantara trim that is attached to the A-Pillar trim in the cantrail area, to separate from the base material on some 13MY Vanquish vehicles (refer to Figure 1). This happens where the trim covers one of the cantrail attachment points.

If a Vanquish comes to your Dealership that has this problem, do the workshop procedure that follows to correct it.
