## QUARANTINE NOTICE

| Reference number: | QN-13-0065 | Issued: 29 June, 2017 |
| Subject: | Incorrect configuration of DB11 TPMS | |
| Model(s): | DB11 | |

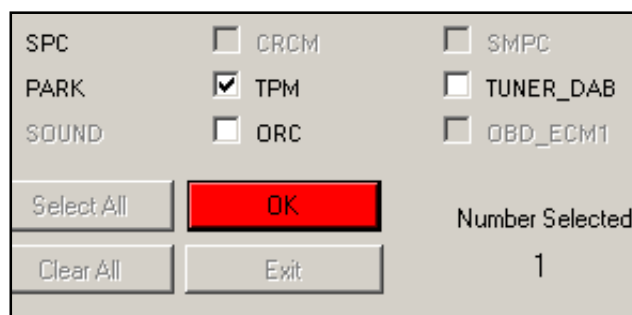
Figure 2

4. Select "TPM" from the list of available modules and click "OK" (refer to Figure 2).

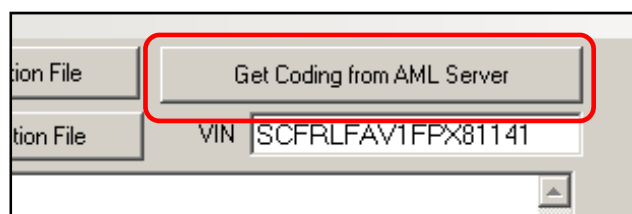
Figure 3

5. Select "Get Coding From AML Server" (refer to Figure 3)

**Note:** The VIN for the connected vehicle will be shown.

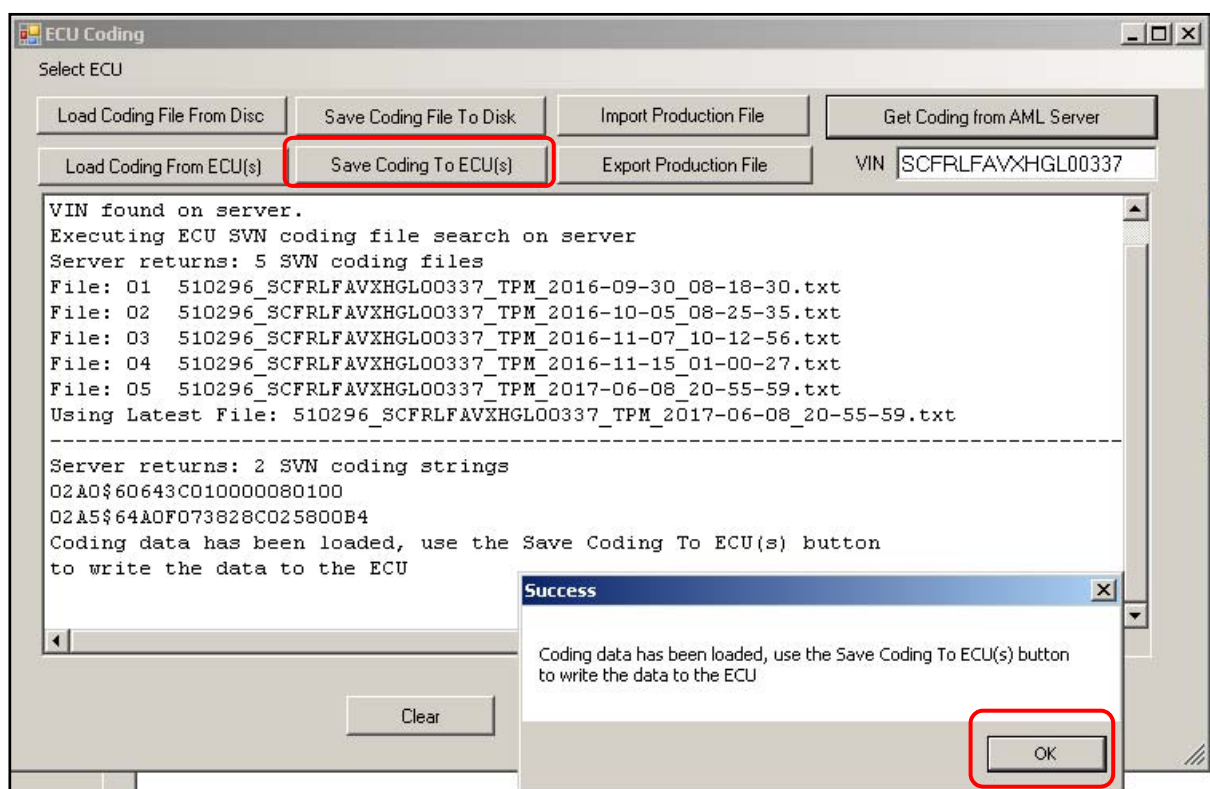
Figure 4

6. AMDS will then connect to the AMDS server and download the Coding Data files for the selected module and VIN. If there are several software files, the newest will be opened.
7. If the files are correctly downloaded, click "OK". To write the Coding Data to the module, click the "Save Coding to ECU(s)" (refer to Figure 4)
